Polymeric Coated Corrugated Steel Pipe Durability Study Update: October 27, 2016

Field Performance of Polymer Coated CMP Cass County Minnesota State Hwy 84 Pine River, MN to Longville, MN

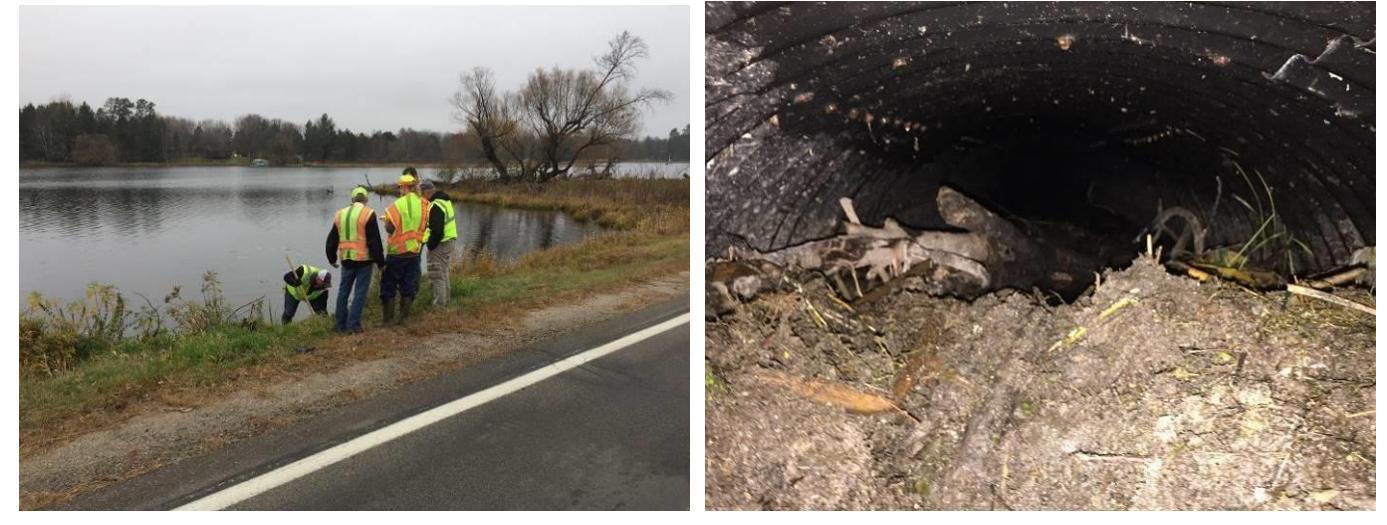
Location #1 at mile post 0.60 – single 28" X 20" Pipe Arch Shape

Pipe Rating – Unknown 0 (Not able to rate, not visible). Most of the pipe was submerged with beaver dam on the downstream end. The top of the culvert was visible and looked in good condition.

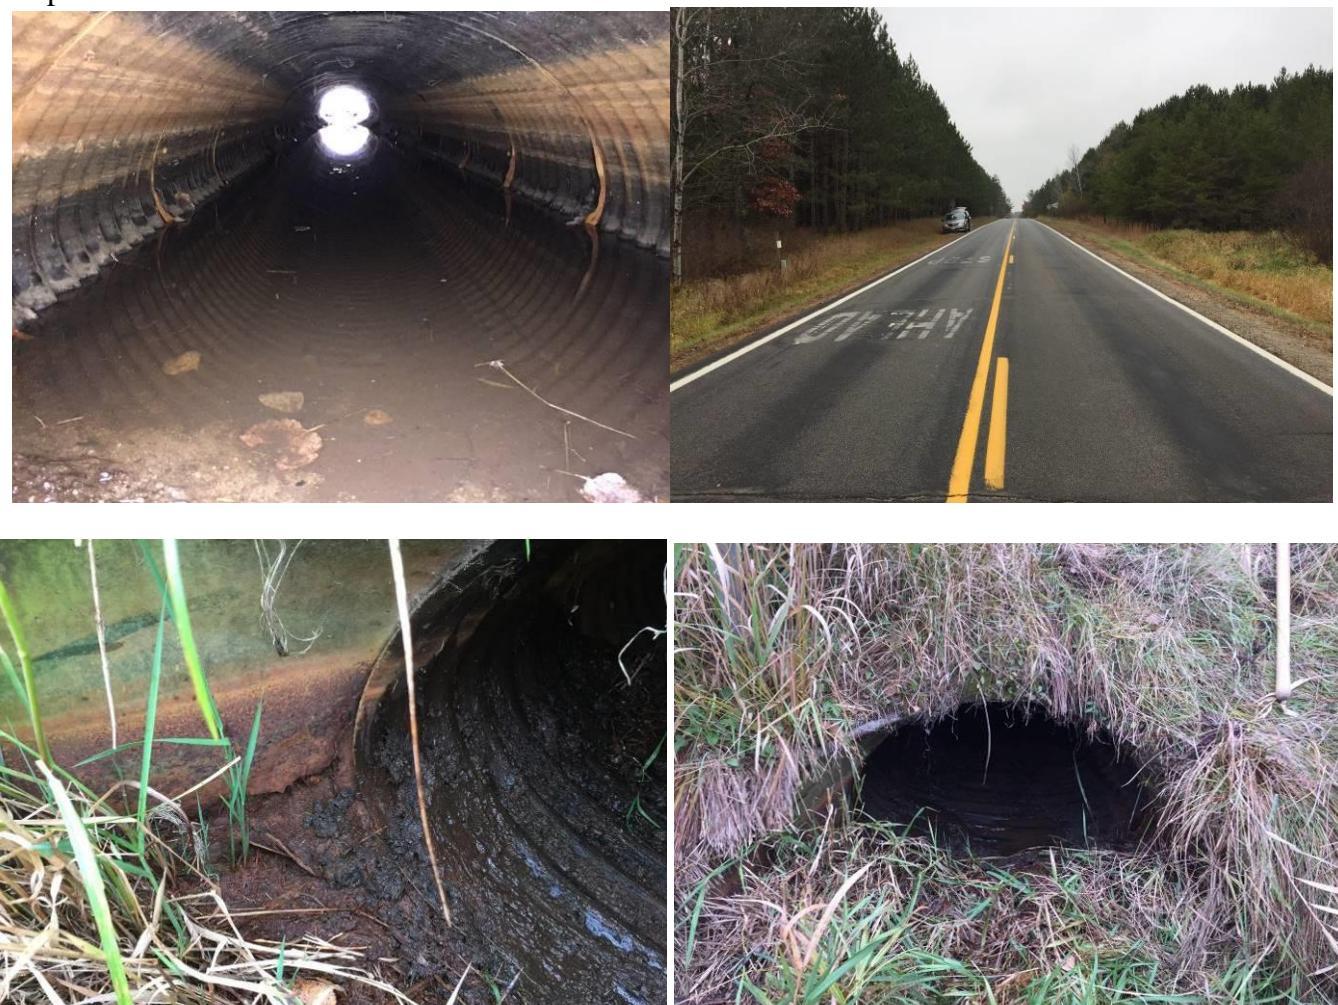
Location #2 at mile post 2.60 – 35" X 29" Pipe Arch Shape

Pipe Rating – Still Okay 2 (Fair - some wear, but structurally sound) Site was wet with some standing water in the pipe culvert. The outlet end required cleaning. The galvanized end section was rusted through. The polymer culvert was in good shape with minor delamination at a few riveted seams.

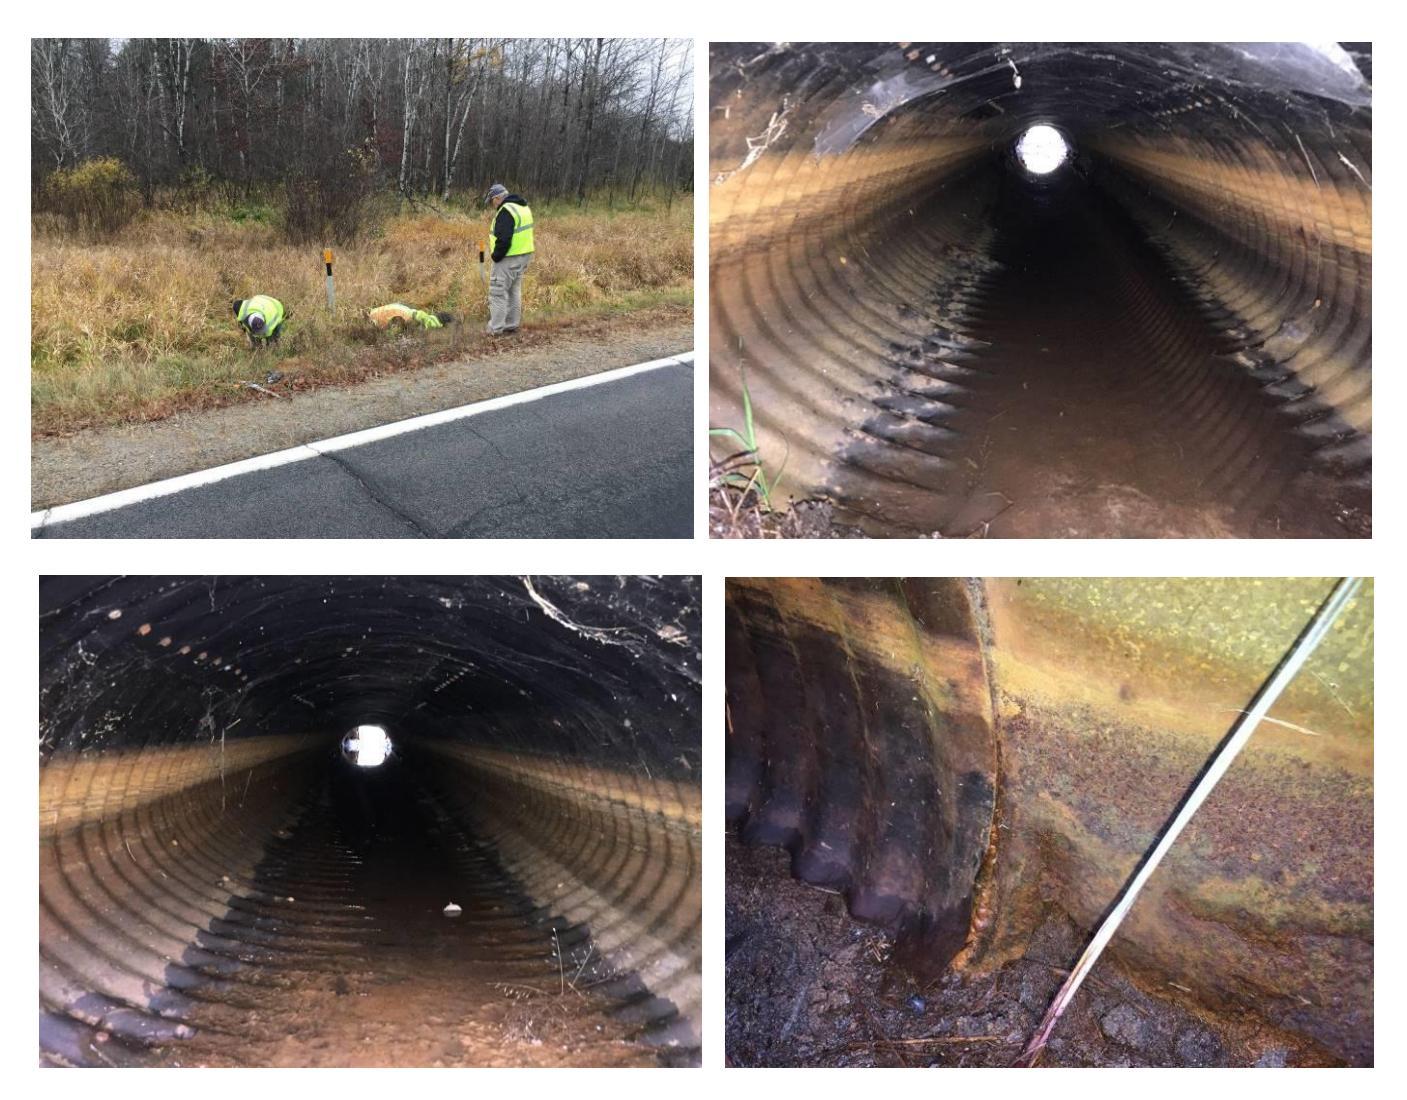
Location #3 at mile post 2.61 – 35" X 29" Pipe Arch Shape

Pipe Rating – Still Okay 2 (Fair - some wear, but structurally sound). The site was wet with some standing water in the pipe culverts. The galvanized end section was rusted through. The polymer culvert was in good shape with minor delamination on the inlet end.

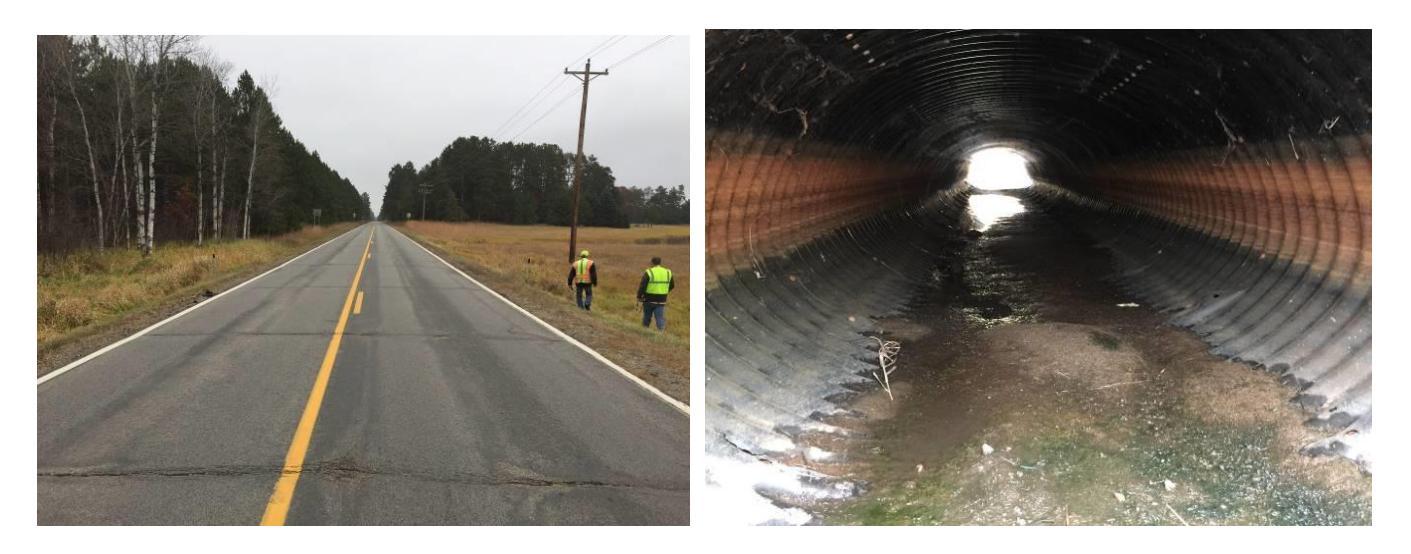
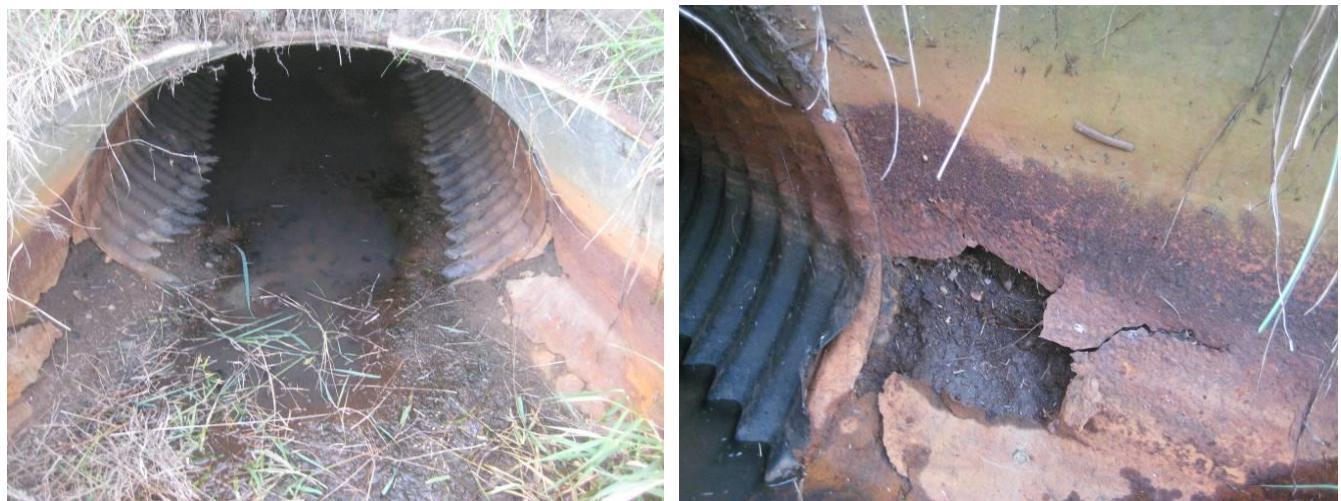
Location #4 at mile post 2.73 – 42" X 29" Pipe Arch Shape

Pipe Rating – Still Okay 2 (Fair - some wear, but structurally sound). The pipe appeared to be in good shape with minor delamination at a few riveted seams. The galvanized end section was rusted through.

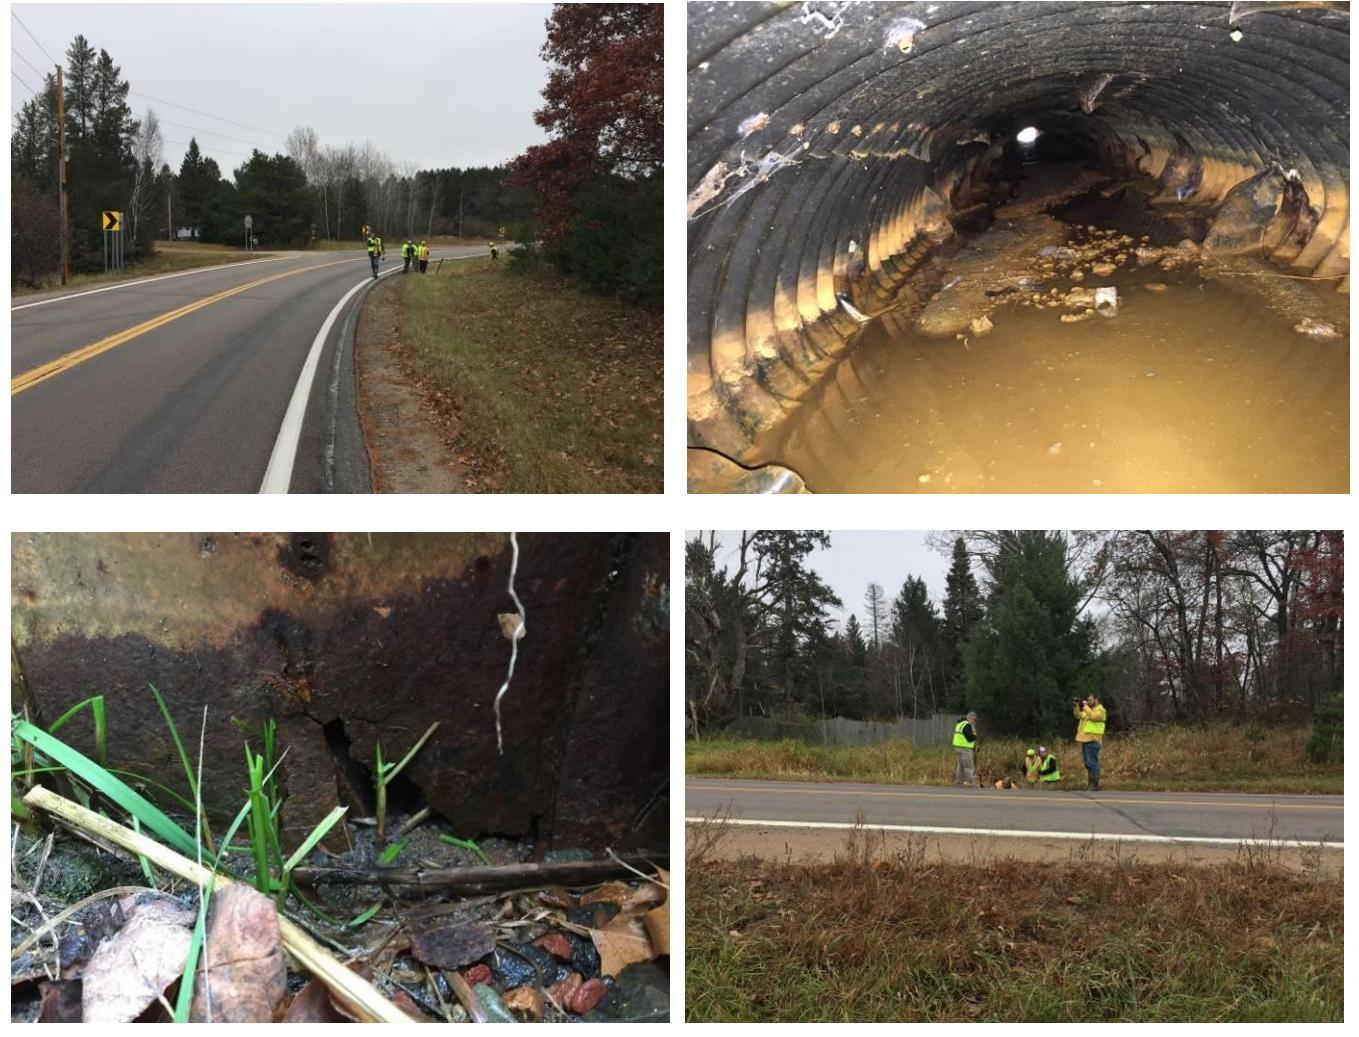
Location #5 at mile post 12.81 – 28" X 20" Pipe Arch Shape

Pipe Rating – Still Okay 2 (Fair - some wear, but structurally sound). There was delamination throughout the culvert, however no perforations were in the base steel of the culvert. The galvanized end section did show corrosion with pitting through the steel.

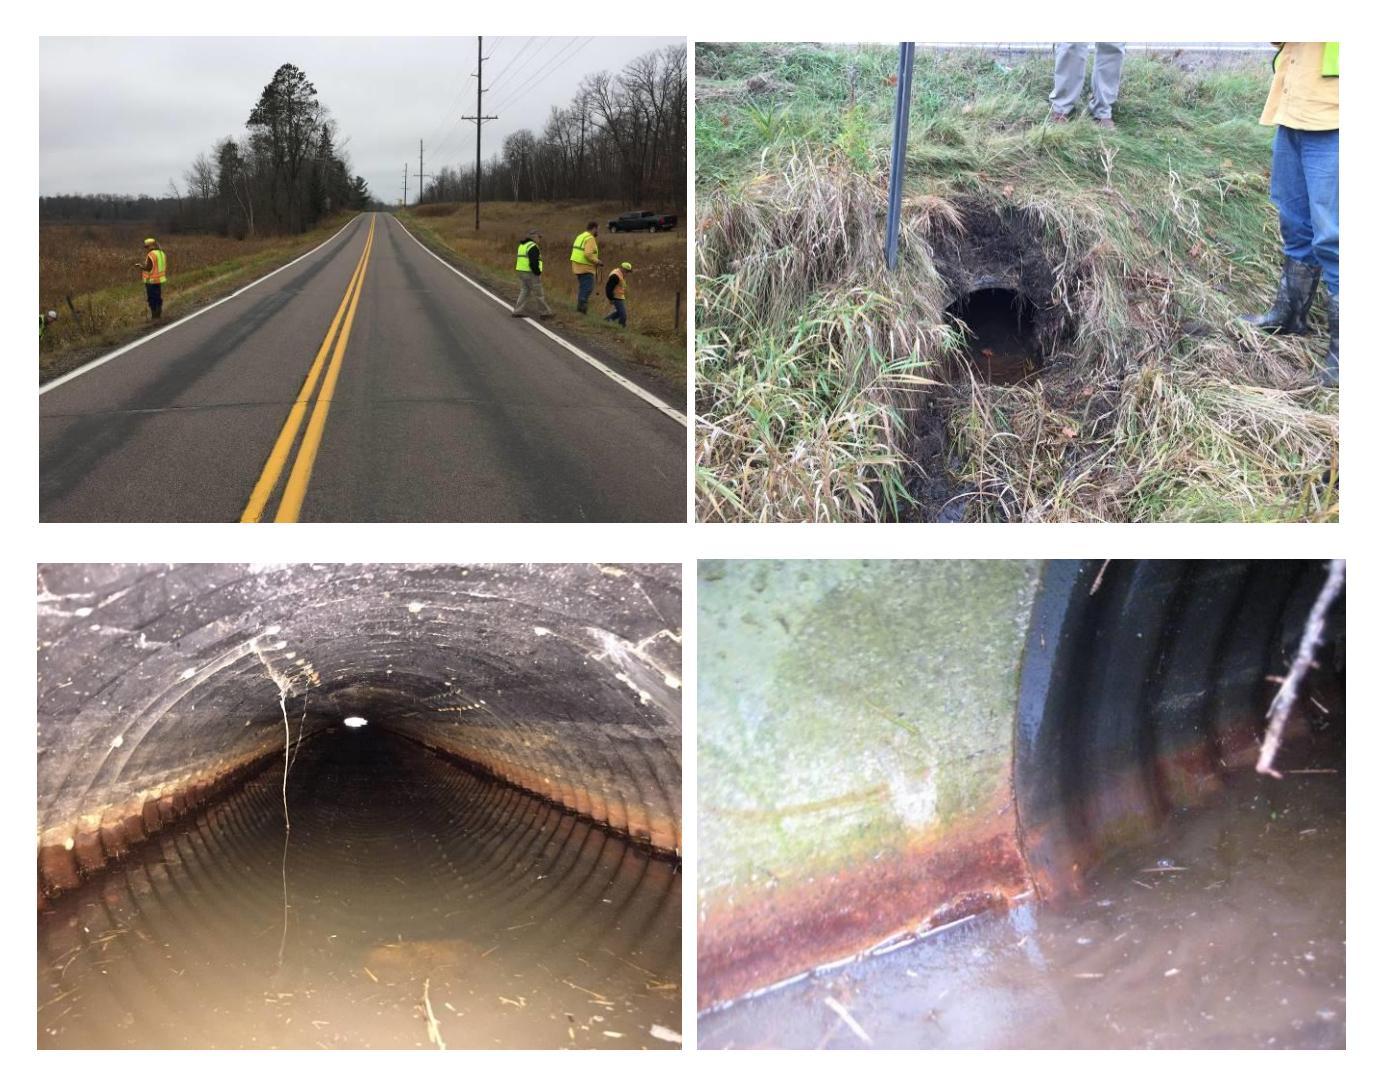
Location #6 at mile post 17.55 – 28" X 20" Pipe Arch Shape

Pipe Rating – Still Okay 2 (Fair - some wear, but structurally sound). The pipe had standing water on the outlet end. The pipe coating was in good condition. The polymer coating is adding service life to the culvert based on the condition of the galvanized end section.

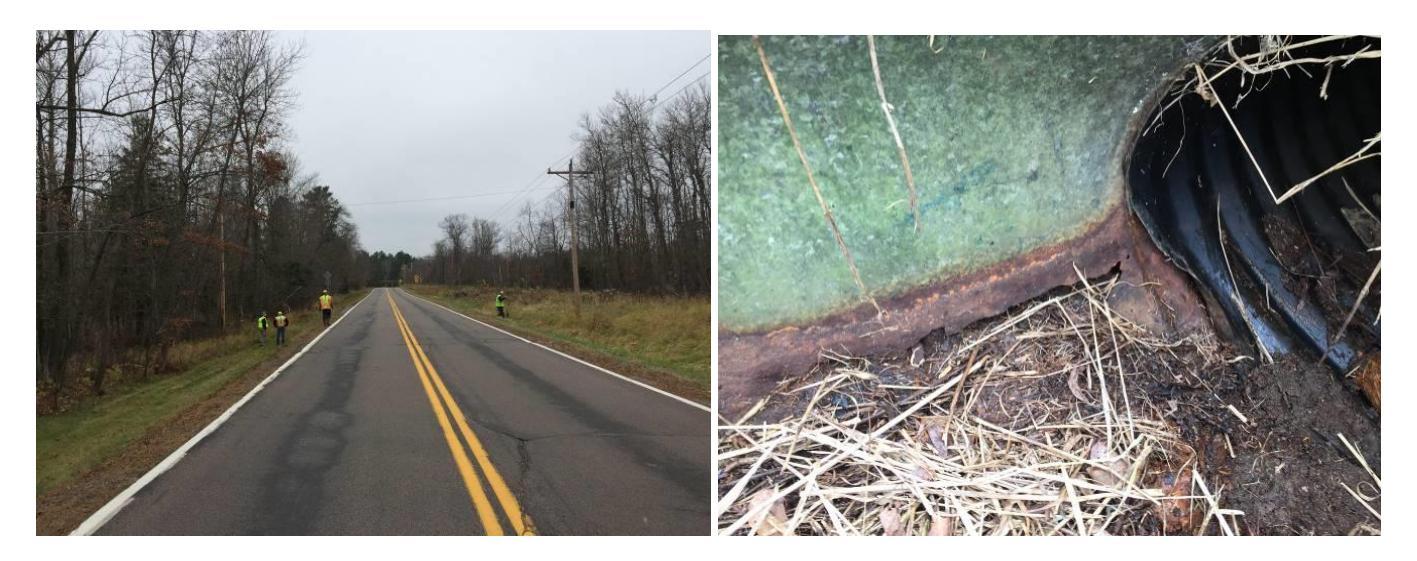
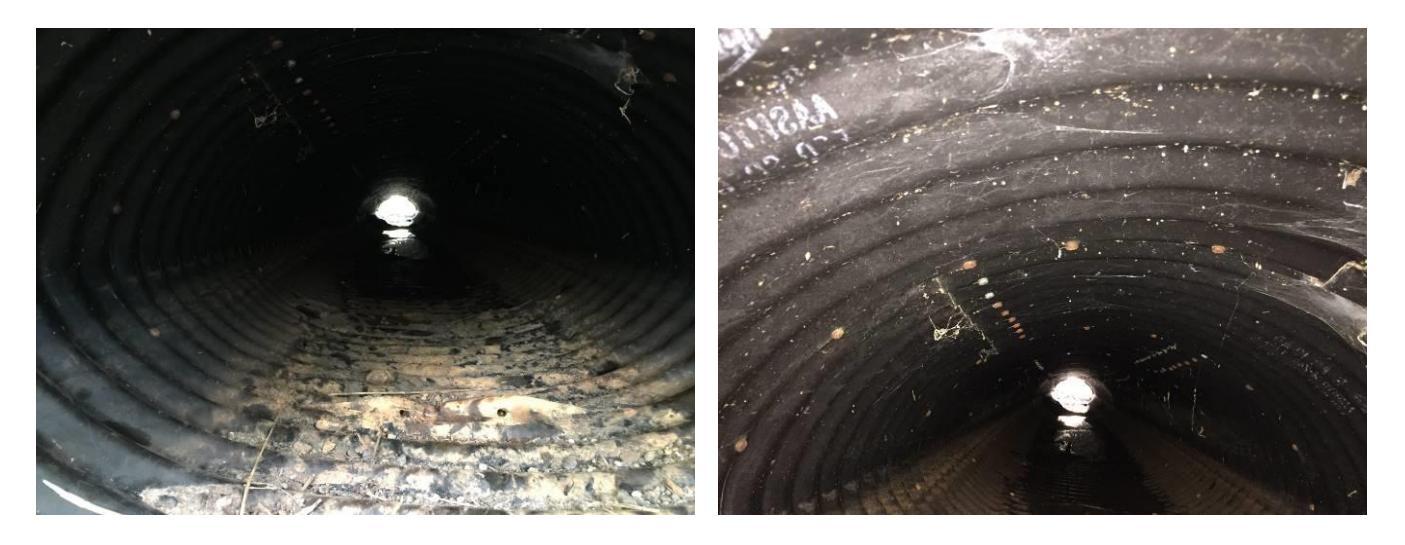
Location #7 at mile post 18.48 – 28" X 20" Pipe Arch Shape

Pipe Rating – Still Okay 2 (Fair - some wear, but structurally sound). The pipe was in good shape with minor delamination on the inlet end and at a few seams. The galvanized end section was rusty through.

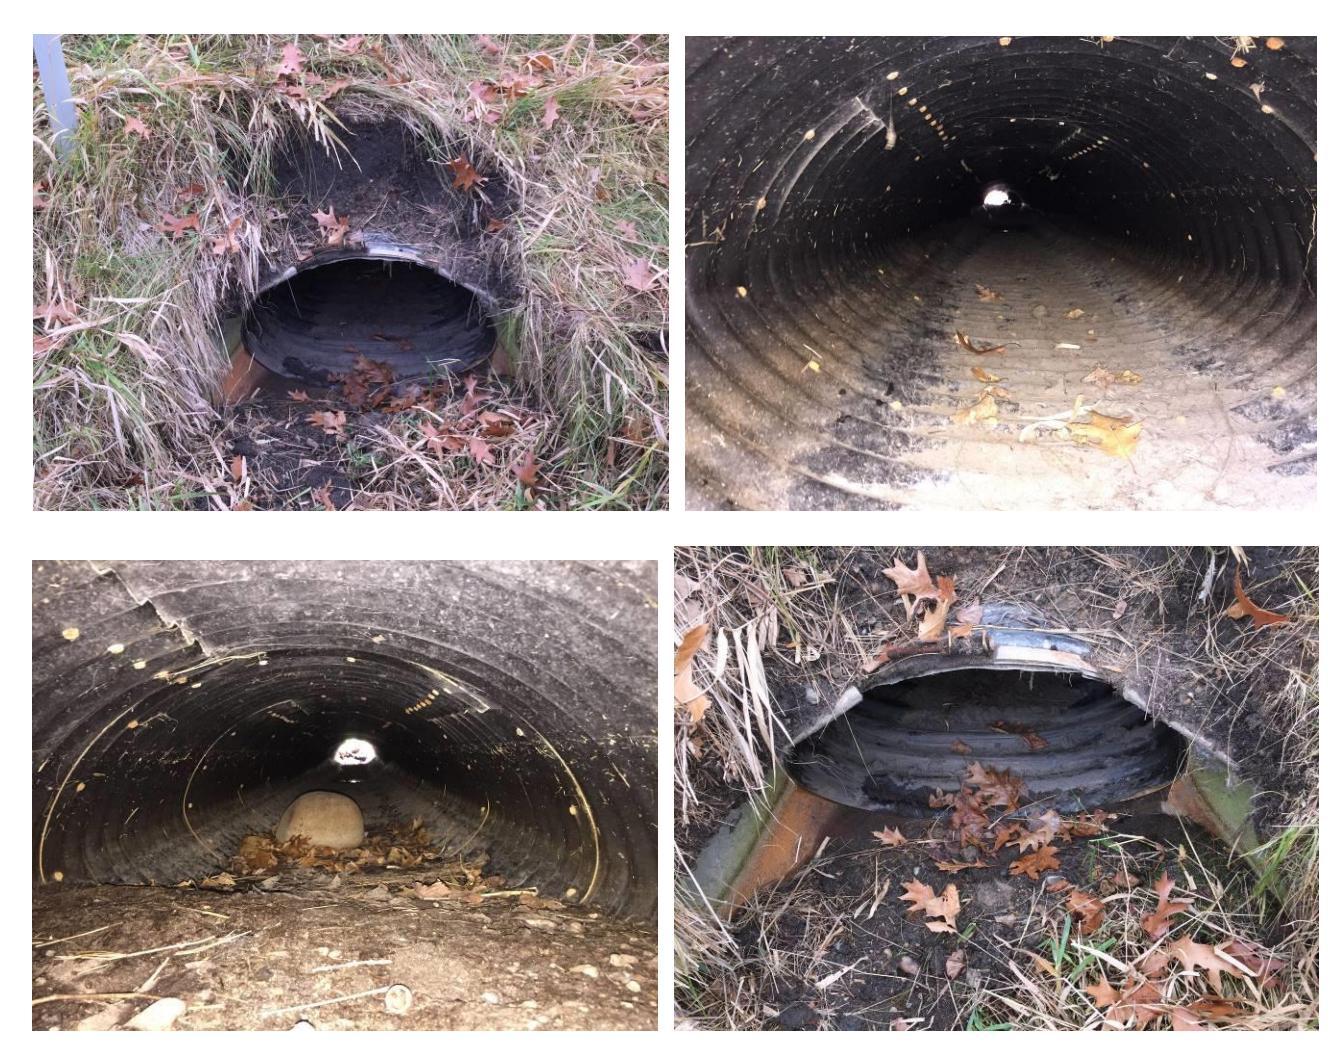
Location #8 at mile post 18.83 – 28" X 20" Pipe Arch Shape

Pipe Rating – Still Okay 2 (Fair - some wear, but structurally sound). There was sediment in the outlet of the pipe with a boulder resting in the invert. The outlet had sediment which needed to be cleaned for observation of the invert. The polymer coated pipe is in good shape. The galvanized end section is showing corrosion. Most of the culvert was dry at time of inspection.

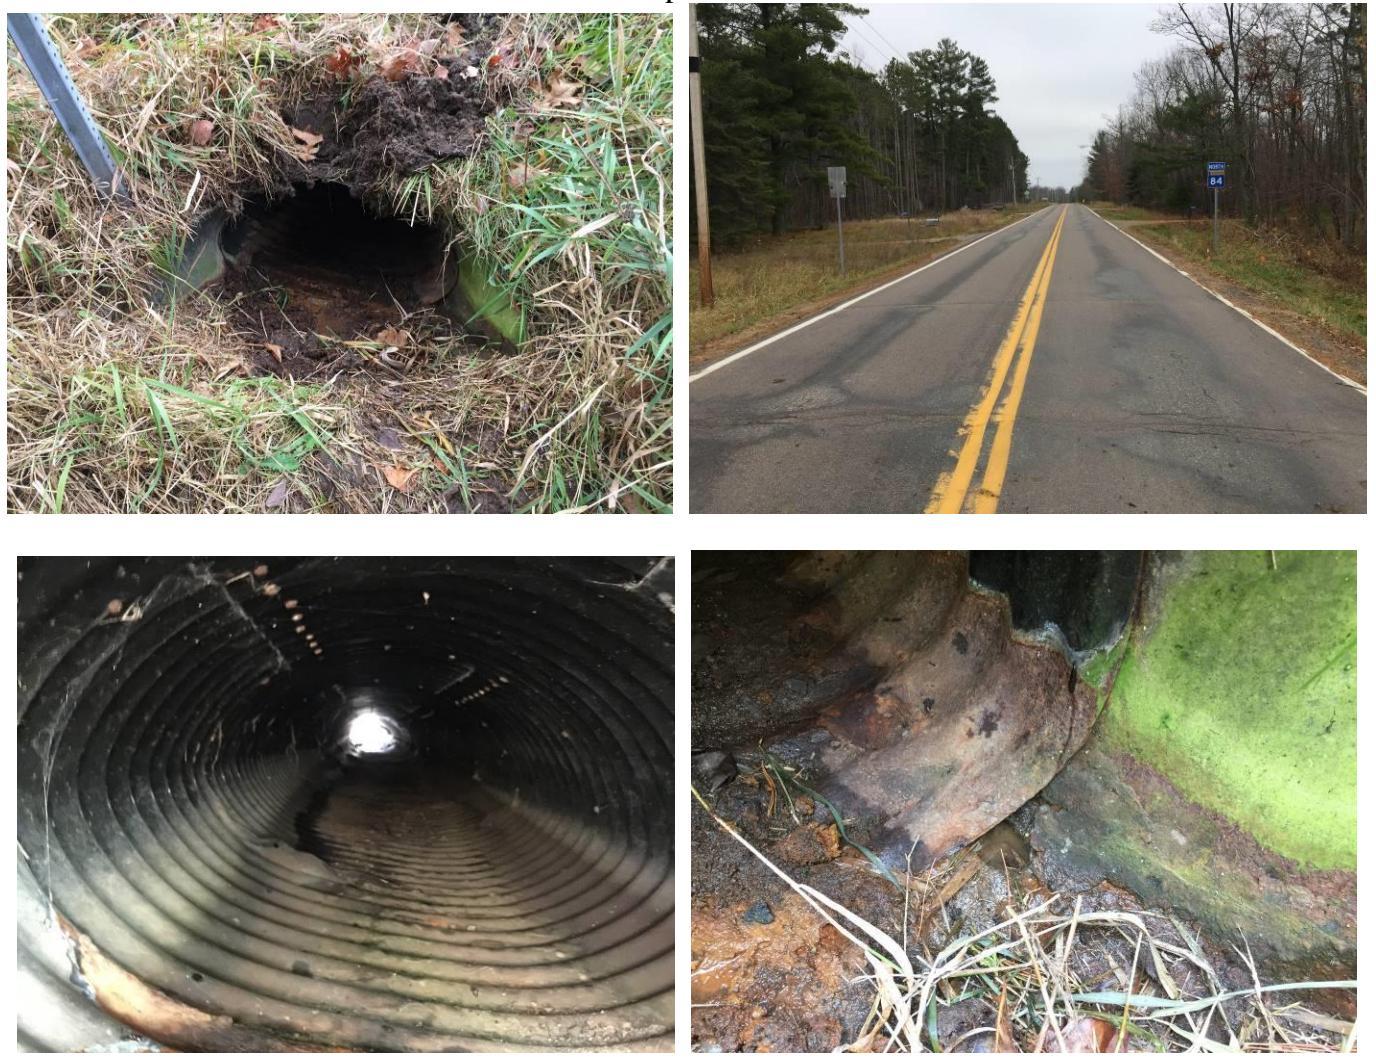
Location #9 at mile post 19.11 – 28" X 20" Pipe Arch Shape

Pipe Rating – Fix in project 3 (Poor – deteriorated, consider for repair or replacement). The polymer coating on the inlet end delaminated a few feet into the inlet. There was a bump in the road over the culvert.

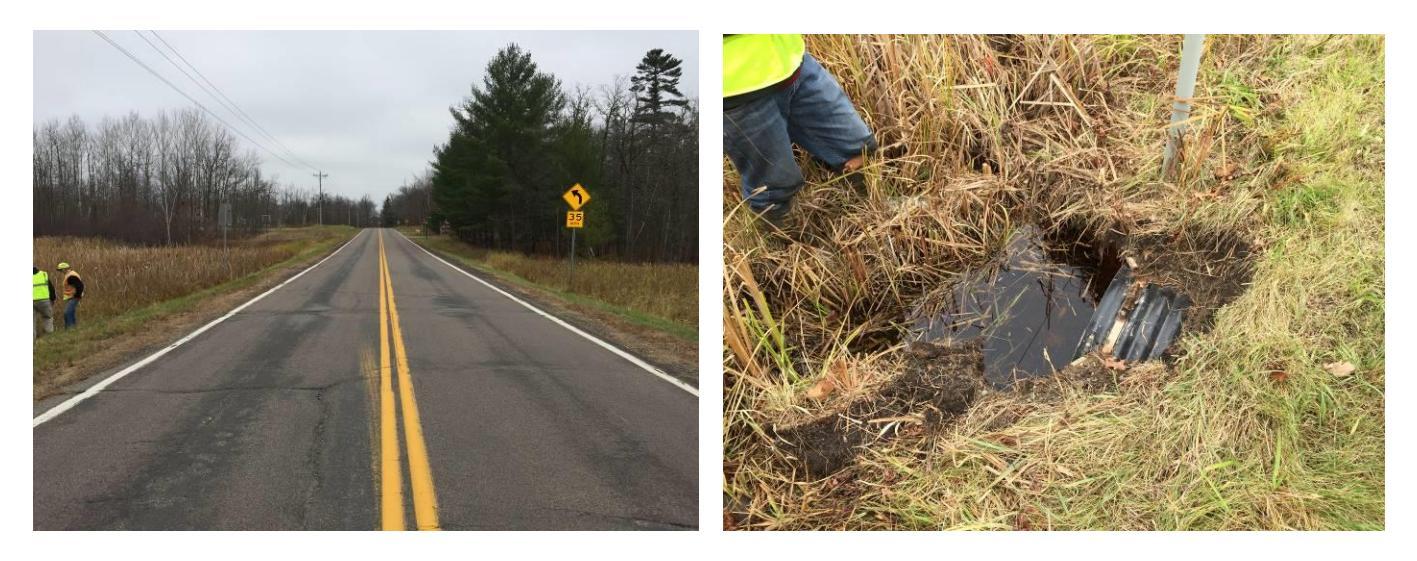
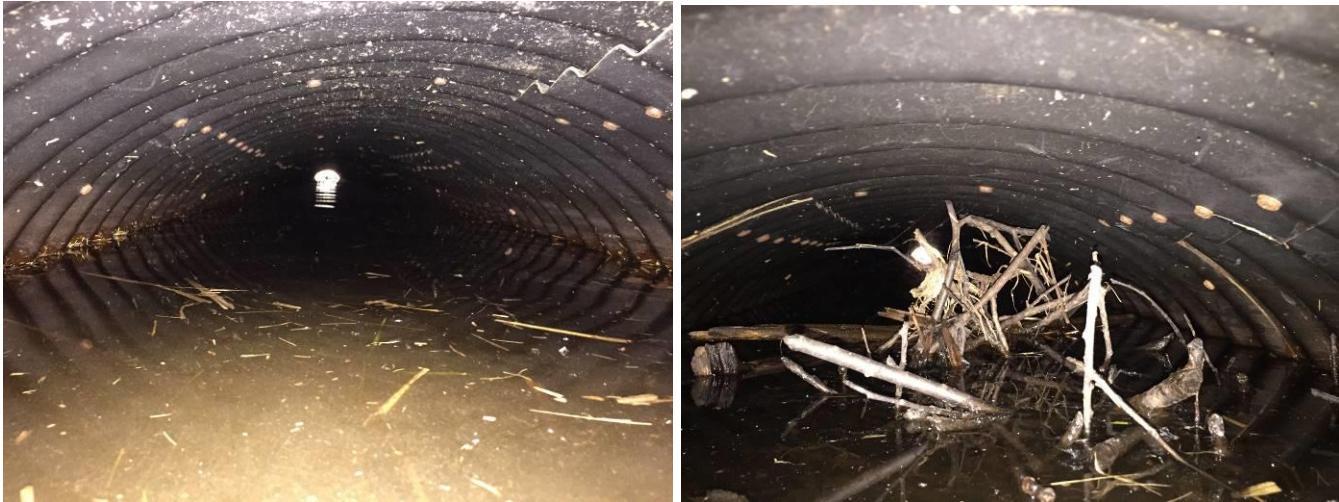
Location #10 at mile post 19.27 – 28" X 20" Pipe Arch Shape

Pipe Rating – Still Okay 2 (Fair - some wear, but structurally sound). Partially submerged with beaver dam on the outlet end. The polymer coating appeared to be in good shape in the invert when reaching through the water.

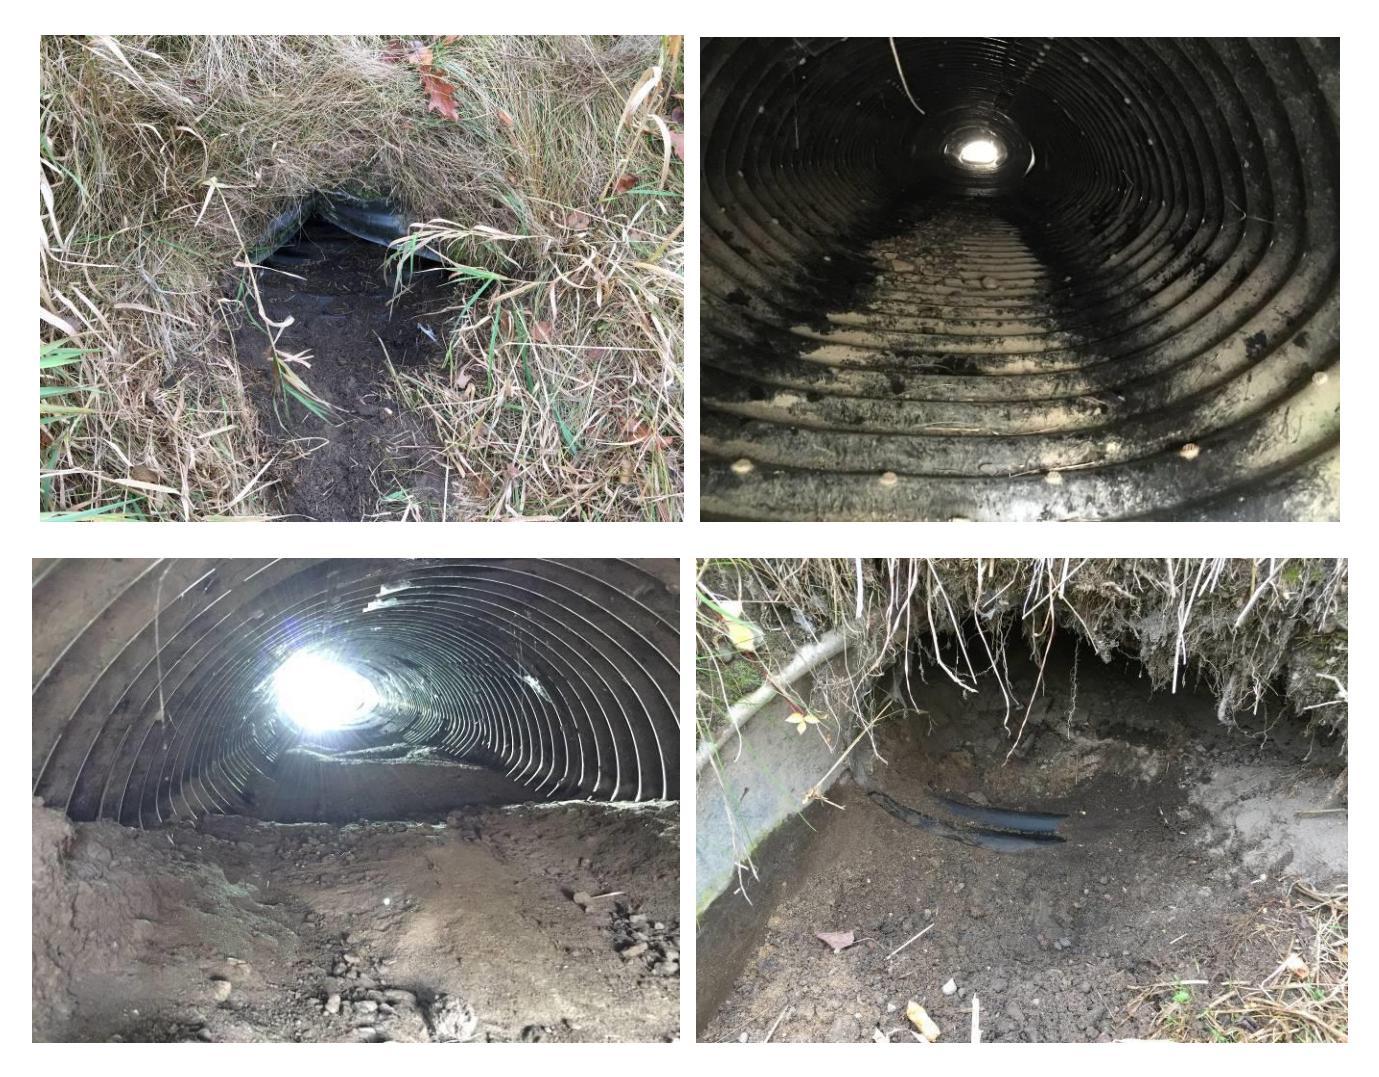
Location #11 at mile post 21.84 – 28" X 20" Pipe Arch Shape Pipe Rating – Still Okay 2 (Fair - some wear, but structurally sound). There was sediment in the outlet end. Most of the pipe was free of sediment. The polymer coating was in good shape.

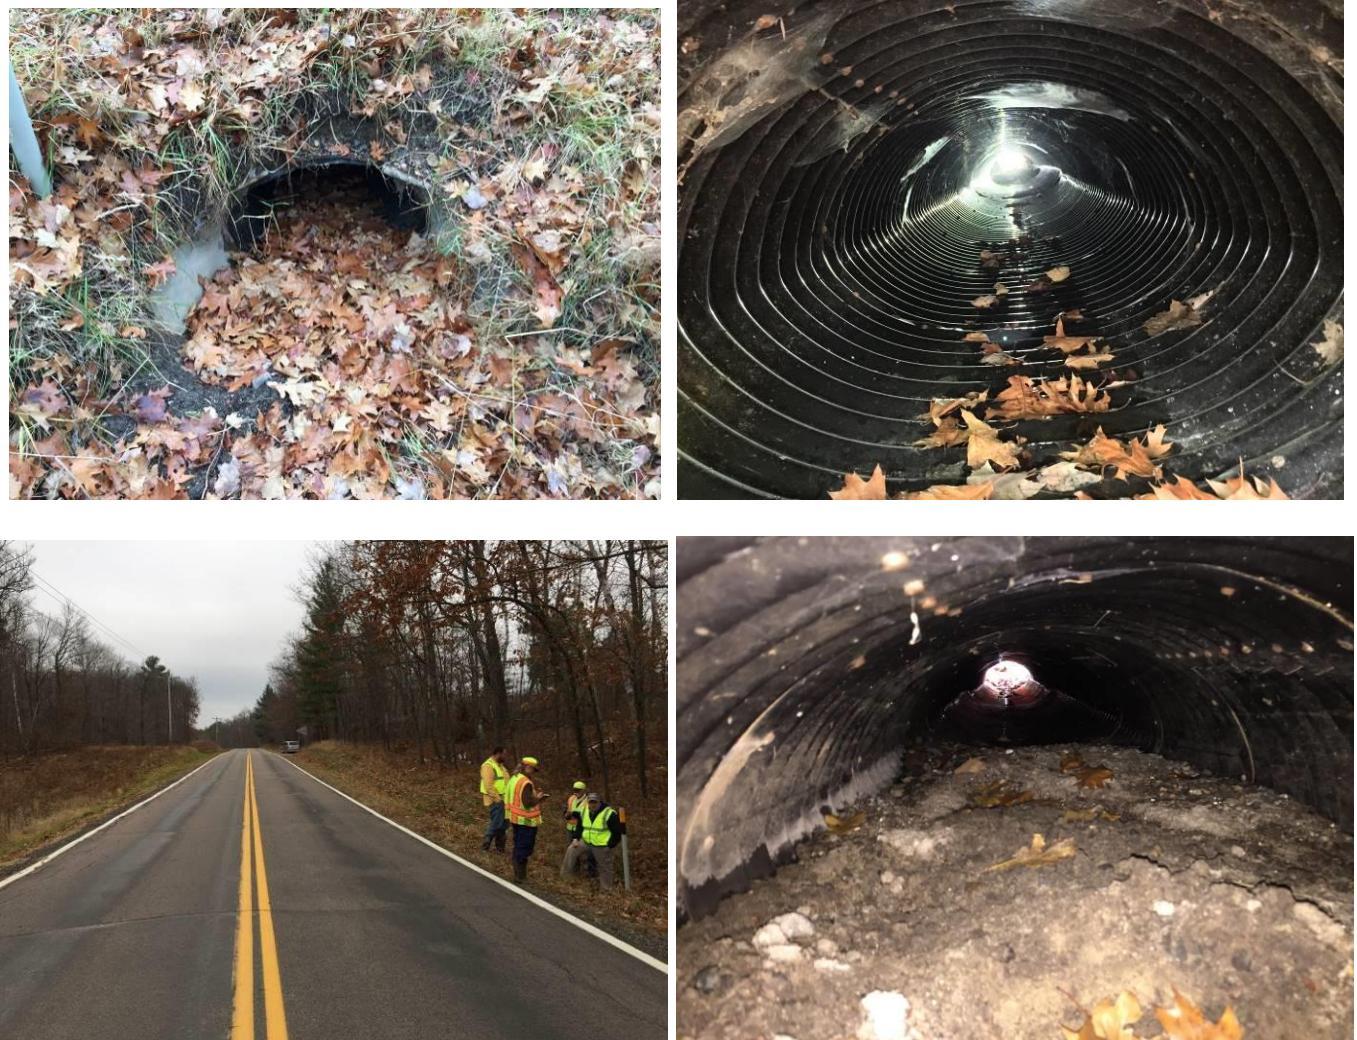
Location #12 at mile post 23.68 – 28" X 20" Pipe Arch Shape

Pipe Rating – Still Okay 2 (Fair - some wear, but structurally sound). The culvert was mostly dry with sand in the outlet and some leaves on the inlet end. The polymer coating was in good condition.

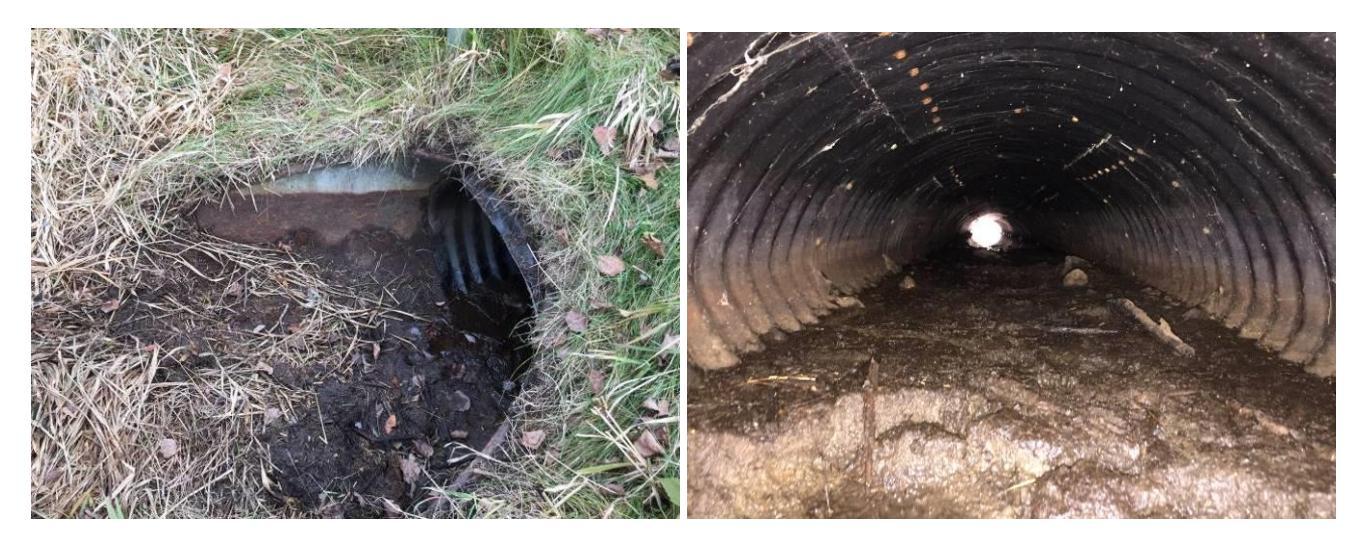
Location #13 at mile post 29.13 – 28" X 20" Pipe Arch Shape

Pipe Rating – Still Okay 2 (Fair - some wear, but structurally sound). Dry with moist sediment on outlet end. The polymer coating was in good condition. The end section shows corrosion with high water line.
