Product Usage Guidelines for Corrugated Steel Pipe

Environmental Guidelines for Corrugated Steel Pipe

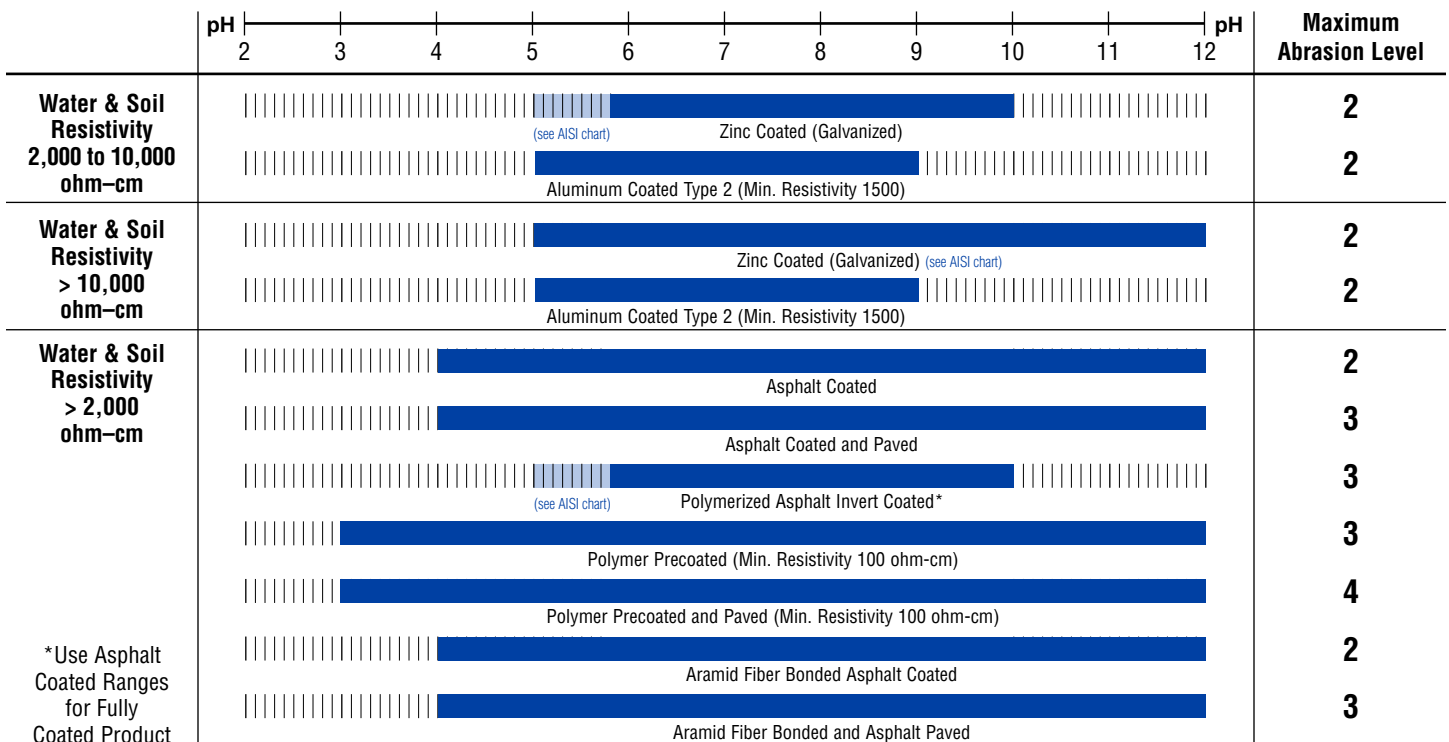
- **Normal Conditions:** pH = 5.8 – 8.0 (for R > 2000 ohm-cm)
- **Mildly Corrosive:** pH = 5.0 – 5.8 and/or for R = 1500 to 2000 ohm-cm
- **Corrosive:** pH < 5.0 (for R < 1500 ohm-cm)

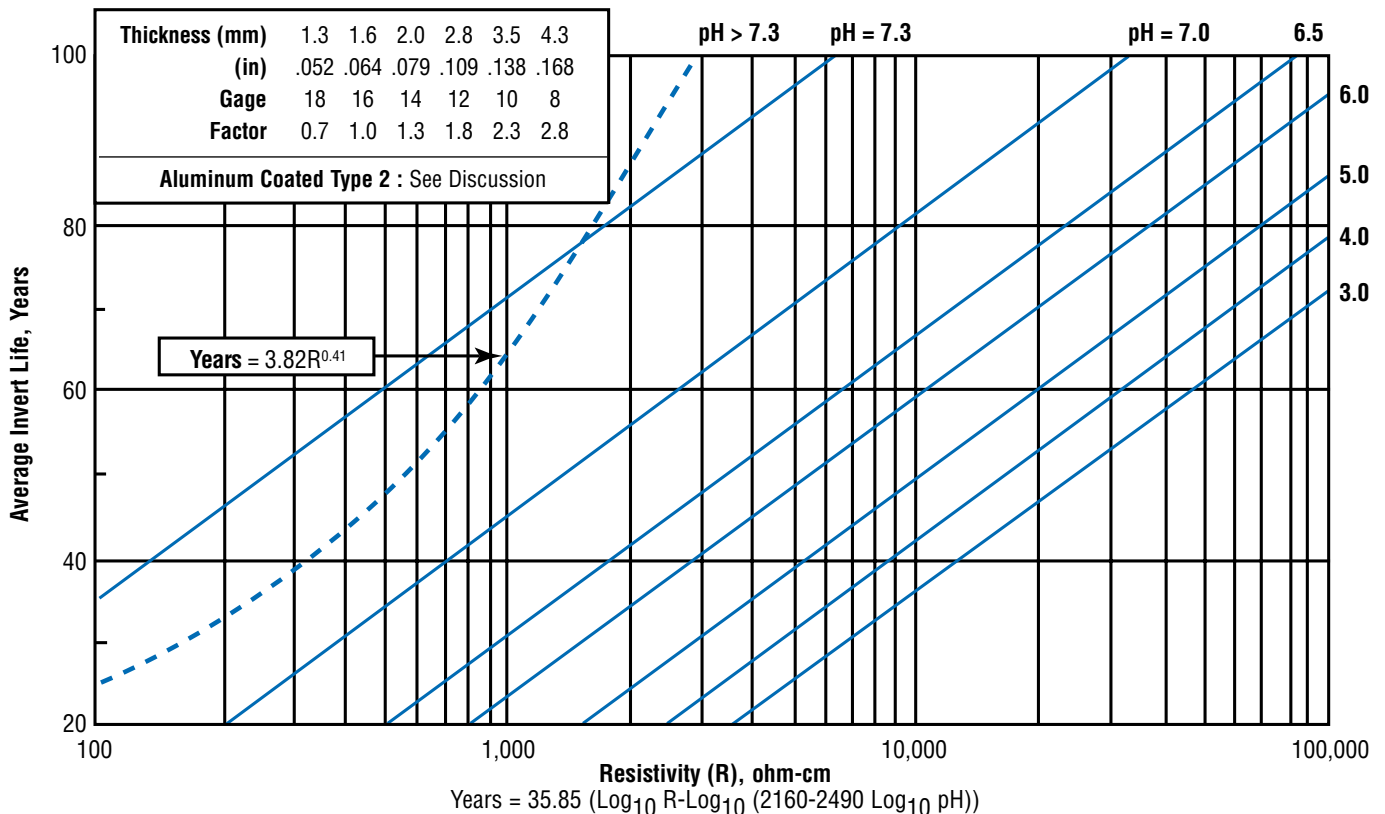
AISI Chart for Estimating Average Invert Life for Galvanized CSP

The service life of CSP can be reasonably predicted based on the environmental conditions, the thickness of the steel, and life of the coating. The most practical method of predicting the service life of the invert is with the AISI (American Iron and Steel Institute) chart shown on page 4.⁹ This chart is based on 16 gage galvanized CSP with a 610 g/m² (2 oz/ft²) coating and can be applied to other thicknesses with the appropriate factor. See discussion above for estimating the service life of aluminum coated type 2.

The AISI chart, which gives service life in terms of resistivity and pH, was developed from a chart originally prepared by the California Department of Transportation (Caltrans).¹⁰ The Caltrans study of durability was based on life to first perforation in culverts that had not received any special maintenance treatment. The results included the combined effects of soil-side and interior corrosion, as well as the average effects of abrasion. For pipes where the pH was greater than 7.3, soil-side corrosion controlled and life could be predicted by resistivity. For pipes where the pH was less than 7.3, the interior invert corrosion generally controlled and both resistivity and pH were important. In the field inspection of 7000 culverts in California for Caltrans, Richard Stratfull, Lead Project

The consequences of small perforations are minimal in a gravity flow pipe such as most storm sewers and culverts and do not accurately reflect the actual service life. Because of this fact, the original curves were converted by Stratfull to average service life curves using data on weight loss and pitting in bare steel developed by the National Institute of Standards and Technology. Since storm sewers and culverts are usually designed with a structural safety factor of at least 2.0, a significant safety factor of 1.5 remains at the end of the service life predicted by the chart. Thus, use of the chart is considered reasonably conservative. The Caltrans Method may be appropriate for use under pressure applications. Where service life is controlled by invert performance, rehabilitation of the invert at the end of the predicted life can extend service life significantly.

Steps in Using the AISI Chart

The durability design chart can be used to predict the service life of galvanized CSP and to select the minimum thickness for any desired service life. Add-on service life values are provided in the table on page 5 for additional coatings.

- 1) Locate on the horizontal axis the soil resistivity (R) representative of the site.
- 2) Move vertically to the intersection of the sloping line for the soil pH. If pH exceeds 7.3 use the dashed line instead.
- 3) Move horizontally to the vertical axis and read the service life years for a pipe with 1.6 mm (0.064 in.) wall thickness.
- 4) Repeat the procedure using the resistivity and pH of the water; then use whichever service life is lower.
- 5) To determine the service life for a greater wall thickness, multiply the service life by the factor given in the inset on the chart.

Additional service life can be provided by increasing the thickness of the base steel in accordance with the factors shown in the Chart for Estimating Average Invert Service Life or with the use of additional coating systems. Add-on service life values are provided in the Tables on page 5.
